Manhole Inspection Summary

Manhole # S3500_045MH

Location Address: **2202 GUILFORD AVE**

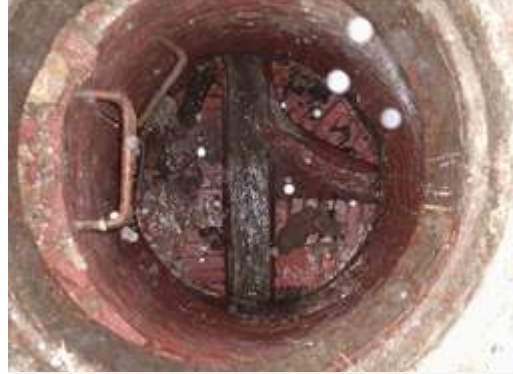
Top View

Corroded steps. Evidence of surcharge - Bench debris.

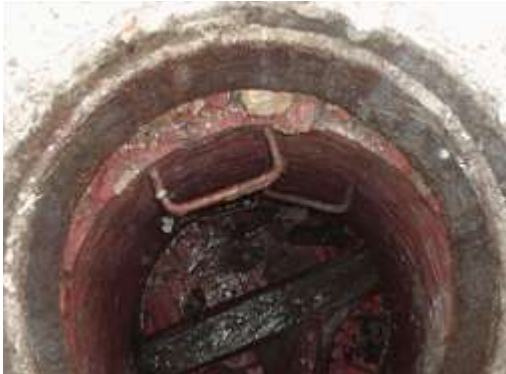
Defect

Frame leaks. Frame offset. Adjustment deterioration and infiltration. Corbel and Barrel infiltration.

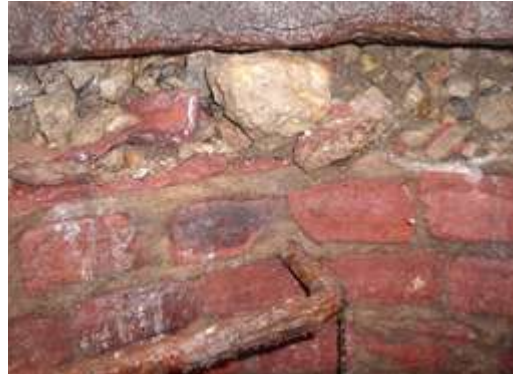
Defect

Frame leaks. Adjustment deterioration and infiltration.

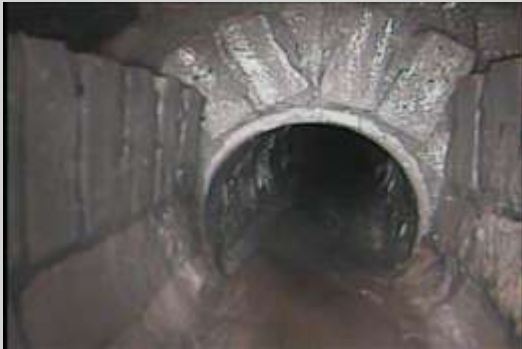
8 in. Circular Gravity Sewer Pipe Out @ 12 O'Clock

Deposits: ☐ None ☐ Mud ☐ Sludge ☐ Debris ☒ Grease

Silt Depth: **0** (in.) Deposits Extent: **Light**

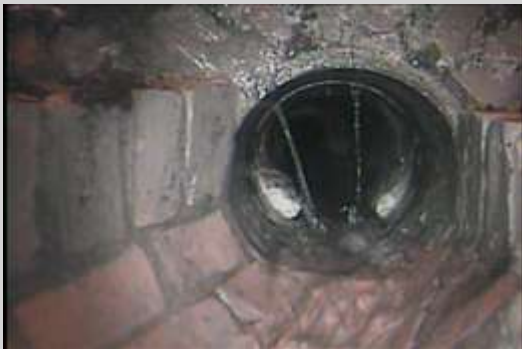
8 in. Circular Gravity Sewer Pipe In @ 3 O'Clock

Barrel infiltration. (Active)

Infiltration: **Runner** Pipe Seal Cond: **Cracked**

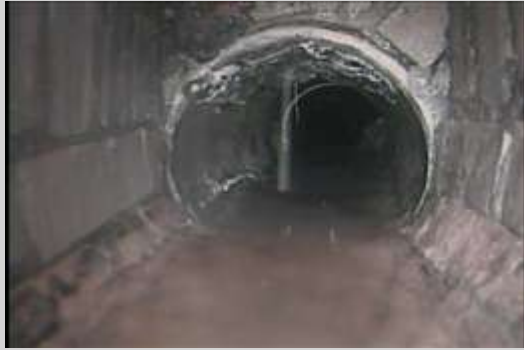
Pipe In @ 6 O'Clock

Infiltration: **Evidence**
